DEPARTMENT OF TRANSPORTATION

Contract #: 04-0120F4Cty: SF/ALA Rte: 80 PM: 13.2/13.9File #: 13.28**WELDING INSPECTION REPORT****Resident Engineer:** Pursell, Gary**Address:** 333 Burma Road**City:** Oakland, CA 94607**Report No:** WIR-007969**Date Inspected:** 30-Jul-2009**Project Name:** SAS Superstructure**OSM Arrival Time:** 1400**Prime Contractor:** American Bridge/Fluor Enterprises, a JV**OSM Departure Time:** 2230**Contractor:** Oregon Iron Works Clackamas, Or.**Location:** Clackamas, OR**CWI Name:** Steve Barnett**CWI Present:** Yes No**Inspected CWI report:** Yes No N/A**Rod Oven in Use:** Yes No N/A**Electrode to specification:** Yes No N/A**Weld Procedures Followed:** Yes No N/A**Qualified Welders:** Yes No N/A**Verified Joint Fit-up:** Yes No N/A**Approved Drawings:** Yes No N/A**Approved WPS:** Yes No N/A**Delayed / Cancelled:** Yes No N/A**Bridge No:** 34-0006**Component:** Hinge-K Components**Summary of Items Observed:**

Summary of Items Observed: On this date, Caltrans Quality Assurance Inspector (QA) Clete Henke was present at Oregon Iron Works, Inc. (OIW) in Clackamas, OR for observation of fabrication of the Hinge K Pipe Beams and related activities including in

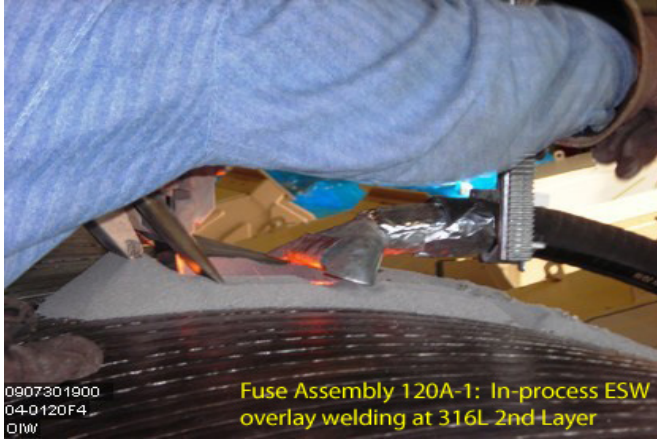
The QA Inspector intermittently observed OIW qualified welder Bounheune Savanh (WID S74) during in-process welding of Soudotape 316L stainless steel overlay to hinge k pipe beam fuse sub-assembly 120A-1. The weld joint is identified as 316L 2nd layer. Mr. Savanh was observed welding in the flat position utilizing automatic electro slag welding (ESW) overlay process with a .5mm x 60mm Soudotape 316L stainless electrode, filler metal brand Soudotape class EQ316L automatic. An OIW helper was observed assisting welder V7 during ESW activity.

The QA Inspector observed OIW QC Inspector Steve Barnett regularly monitoring and recording the in process ESW parameters. The QA Inspector also intermittently observed in process welding parameters and determined that the ESW parameters (1200 amps, 25.2 volts, 254mm/min travel speed) and minimum preheat temperature of 70° F appeared to be in general compliance with the contract requirements and approved OIW Welding Procedure Specification (WPS) 7003.
